Aluminium body repair bay at Jaguar in Coventry in UK

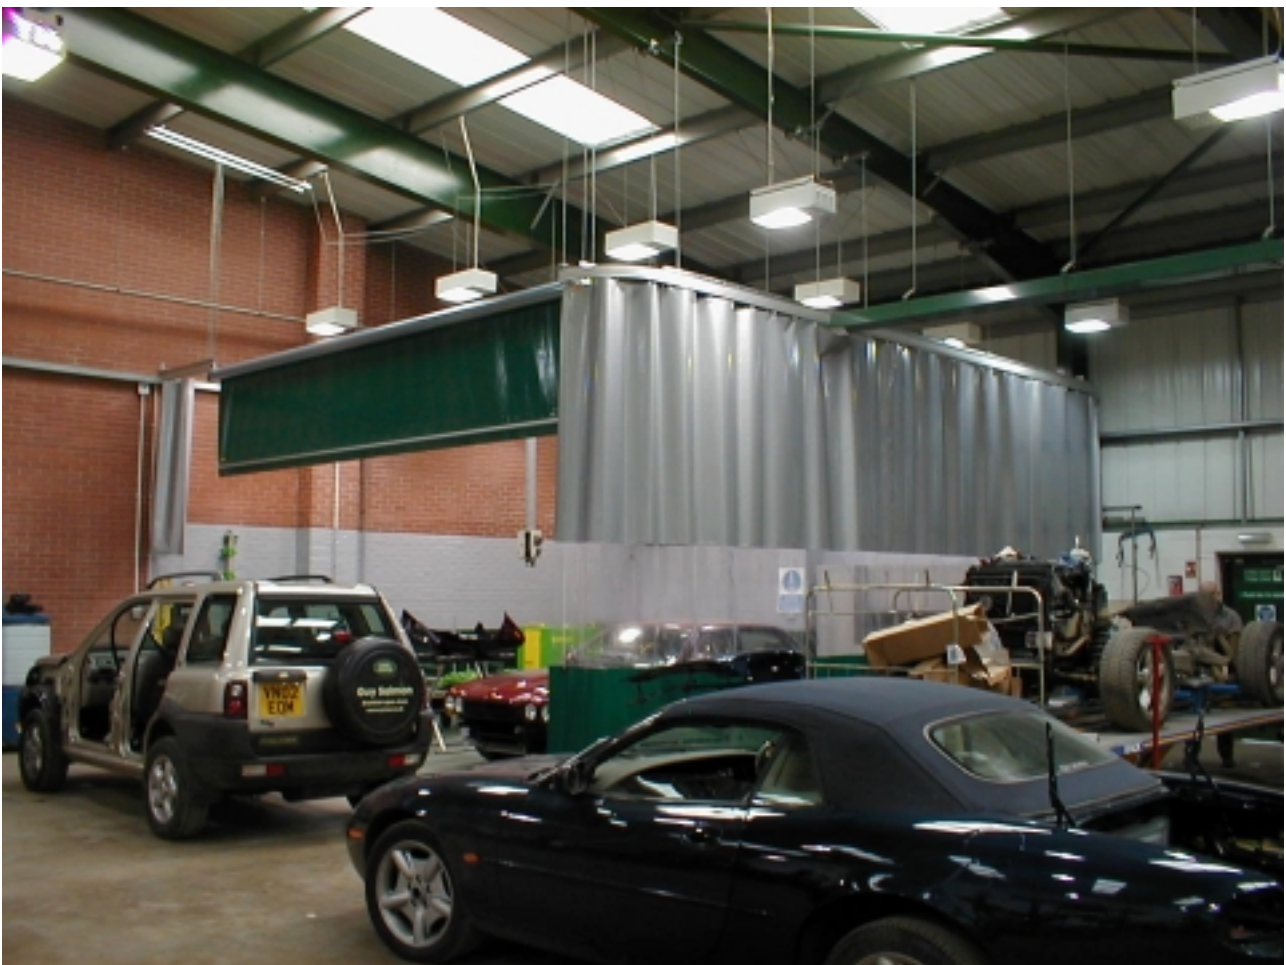
Solution: To prevent contamination from surrounding areas, a 6 m wide and 4 m high power curtain in combination with an 8 m wide and 4 m high combi-curtain on C100-curtain aluminium rail, were selected.
All curtains were delivered in Jaguar's own standard colours, i.e. from bottom to top, green - clear transparent - grey.
The bay can allocate two cars at the same time.
For the extraction, a P160 mobile high vacuum unit was chosen.
