Case Story

Exhaust extraction systems in new Daimler Chrysler car and truck service in Vilnius

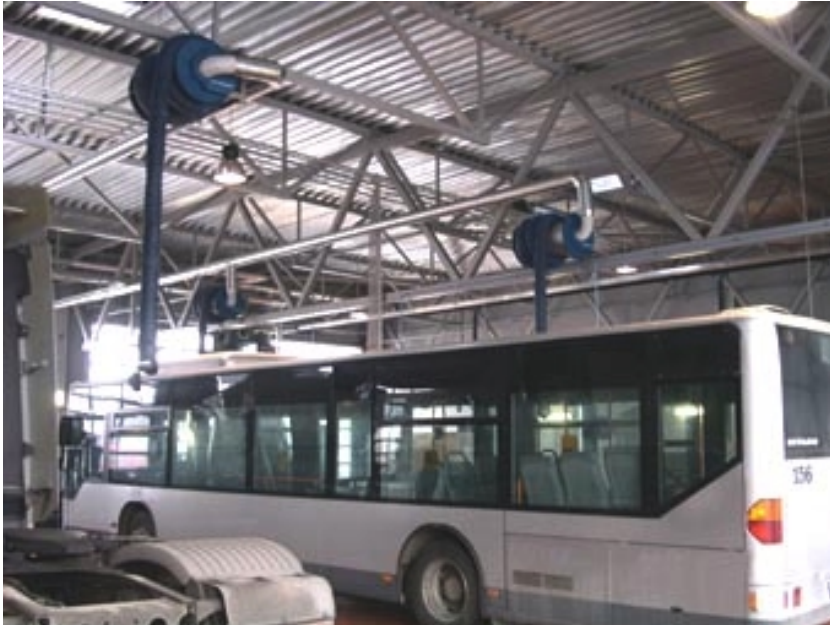
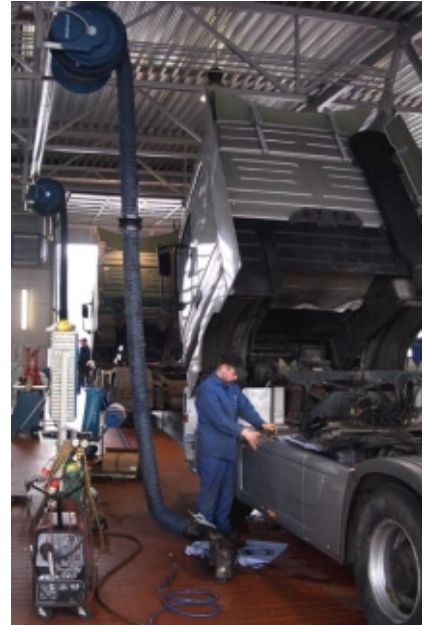
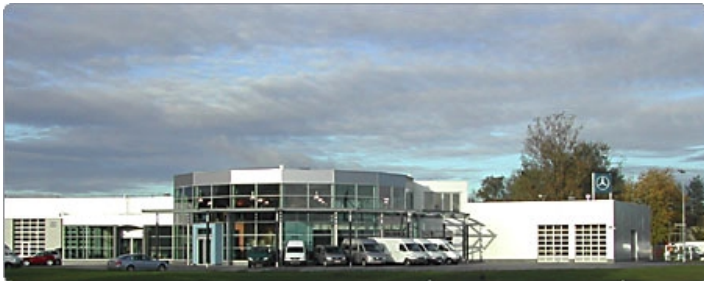
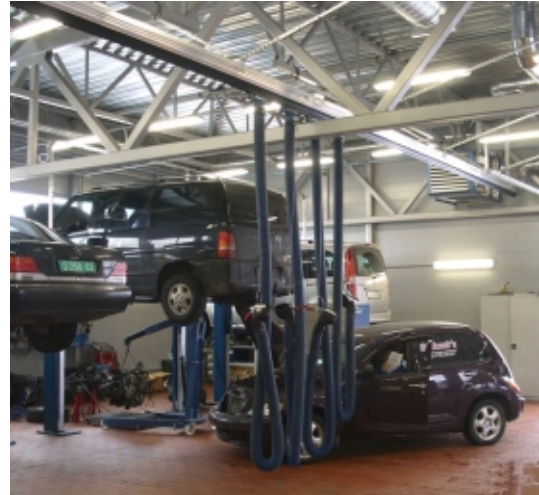
Solution: For truck service there were installed 10 pieces of exhaust hose reels 865, 2 pieces of rail 920 for trucks in motion, 1 piece of rail 920 stationary system for transporters and 1 piece for cars. Total quality of fans (N16 and N24) are 10 pieces and 1 piece of N29, 1.5kW.
